Ice Jam at the Rio Blanco Diversion Weir on the White River in Colorado

A Case Study of In-Stream Structures and Ice

Andrew M. Tuthill

February 2008

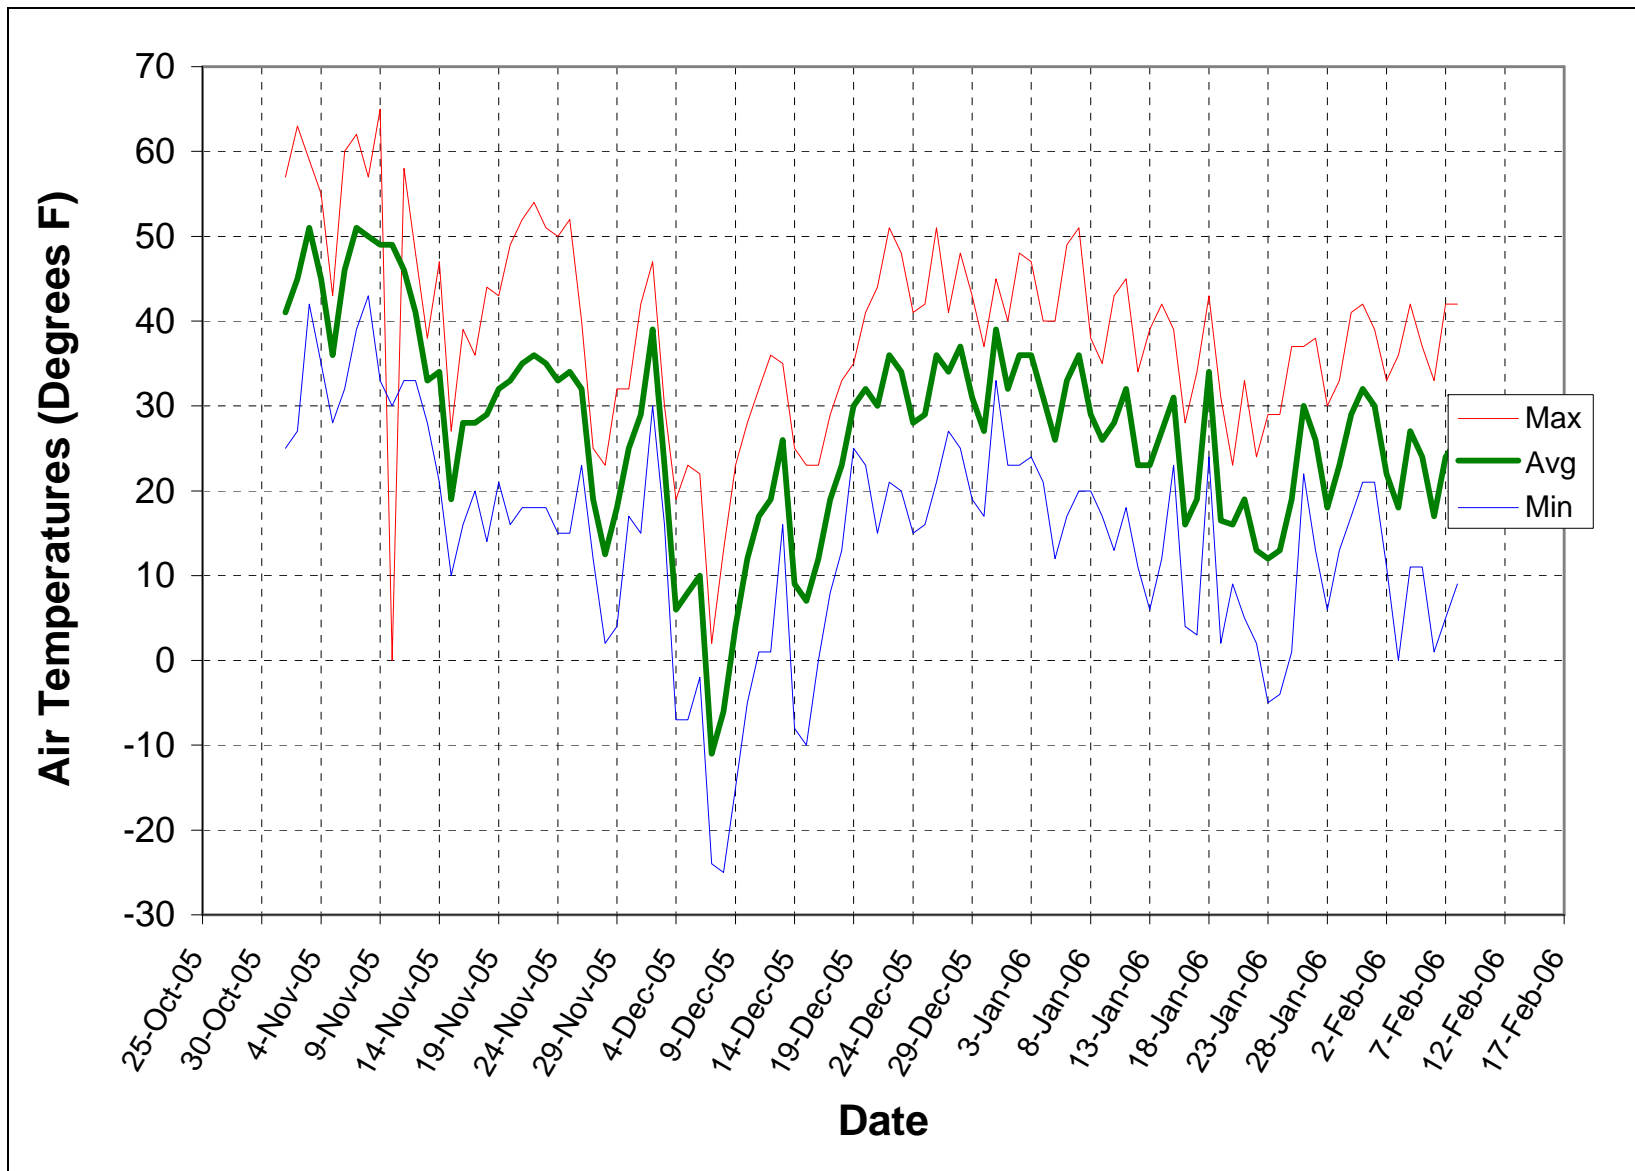
Figure 11. Air temperatures at Meeker, Colorado, airport, showing early December cold spell during which ice jam formed.
